# AMENDMENT OF SOLICITATION

6. AMENDMENT OF (RFP)  
SOLICITATION NO. FBPSC239441

**COLLECTED PROCESS KNOWLEDGE INFORMATION  
FOR THE X-710 TECHNICAL SERVICES BUILDING  
AND ASSOCIATED FACILITIES  
AT THE  
PORTSMOUTH GASEOUS DIFFUSION PLANT,  
PIKETON, OHIO**

**Prepared by  
Fluor-BWXT Portsmouth LLC, Under Contract DE-AC30-10CC40017  
FBP-ER-GEN-BG-RPT-0126, Revision 0**

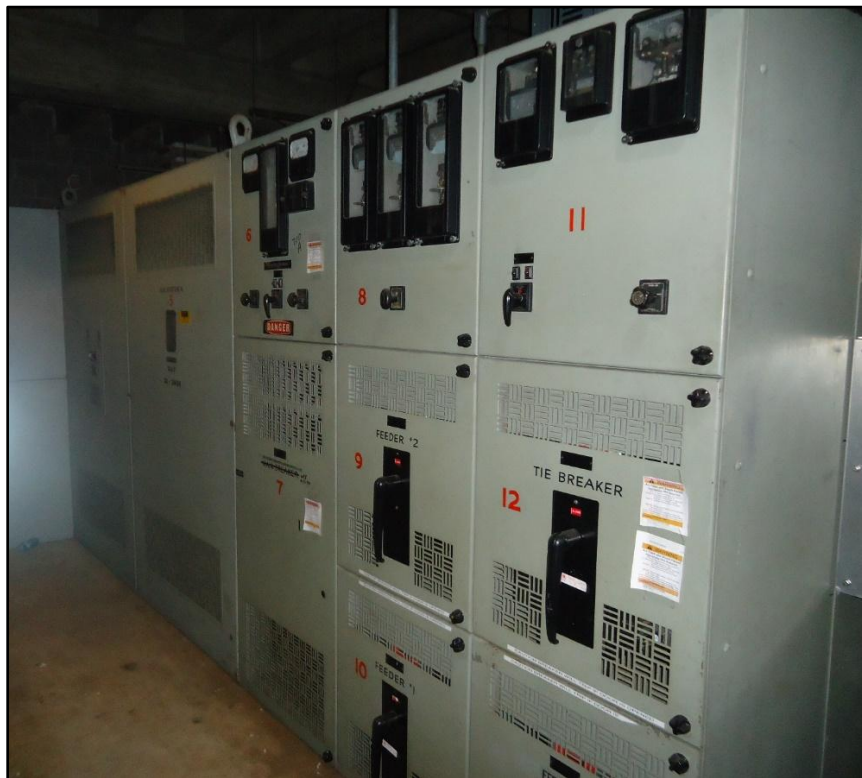
**Figure 2. Room 109 Transformer Room, Electrical Panels**

Room 109 has been a Transformer Room since the building was constructed. Figure 2 shows some electrical panels in this room.

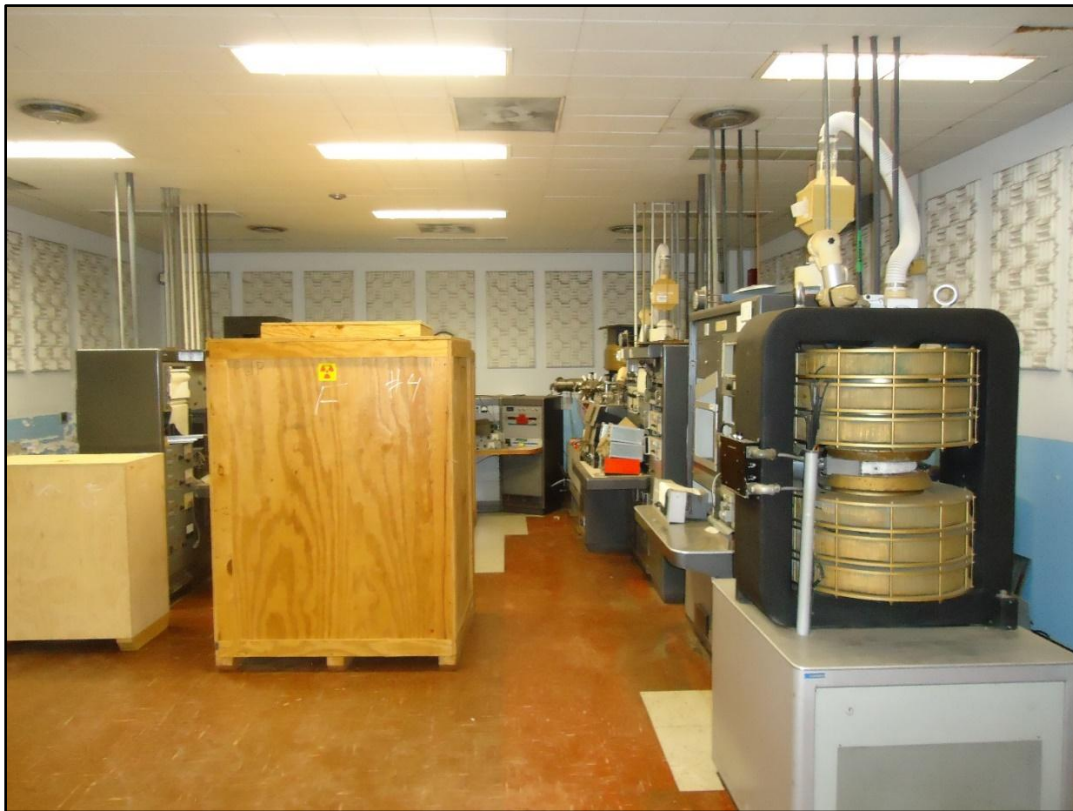
**Figure 3. Room 115 Mass Spectrometer, Looking South**

Originally labeled “Mass Spectrometer Room No. 1” (Room 115) and “Mass Spectrometer Room No. 2” (Room 126), these rooms contained multiple gas phase magnetic sector mass spectrometers. These instruments were used for routine processing of very high quantities of hoke tube, U-tube, and pinch tube

samples for uranium enrichment determination. The 6-inch magnet spectrometers were separated by enrichment range over the entire working enrichment of the three Process Buildings at PORTS. Two 15-inch magnet spectrometer were used for higher accuracy and precision work. These instruments were originally equipped with mercury diffusion pumps that were later replaced with alternate technologies. In the late 1980s, three Finnegan gas phase mass spectrometers (one later transferred out to another facility) were installed and became operational. Small releases of  $\text{UF}_6$  were commonplace primarily from leaking valves on tube type sample containers as well as when hooking up and disconnecting the tubes from the spectrometers. “Gulpers” for these disconnect leaks were possibly implemented in the early 1990s. Gulpers were HEPA filtered ventilation equipped with flexible inlet tubes that were extendable for easy placement near areas where connects and disconnects were being made (i.e., areas which had the highest probability of  $\text{UF}_6$  release). Room 116 and Room 127 were small interior rooms which served primarily as administrative areas within these two material processing areas. Figure 3 shows a mass spectrometer unit in the foreground on the right in Room 115. Figure 4 shows a general view of the work area in Room 126.

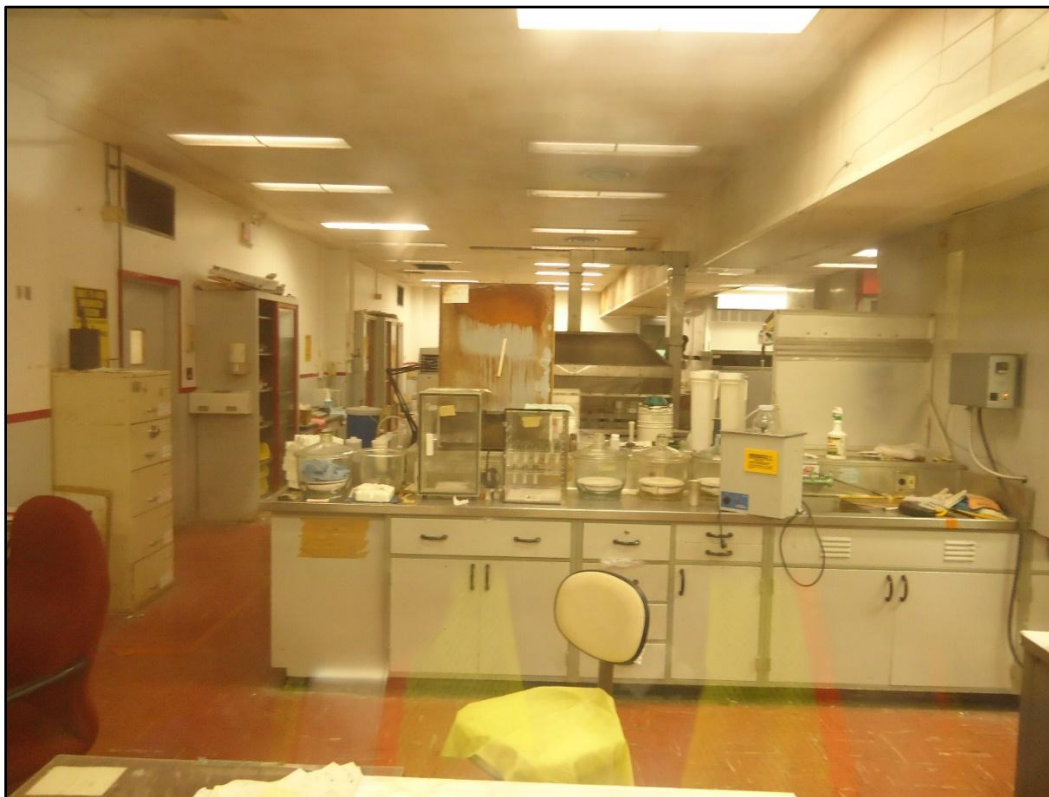
**Figure 5. Room 120, View of Room Window in Room 122, Looking South**

In the early years, cleaning of glassware throughout the laboratory was performed in chromic acid baths; in later years this was replaced by sulfuric acid baths with NOCHROMIX® (a patented inorganic oxidizer). Specific rooms where this was the case are identified, however this may not be a complete list due to the decades-long operational history and limited knowledge of current long-term employees. Figures 5 and 6 show general views of the rooms used by the Uranium Chemistry Group.

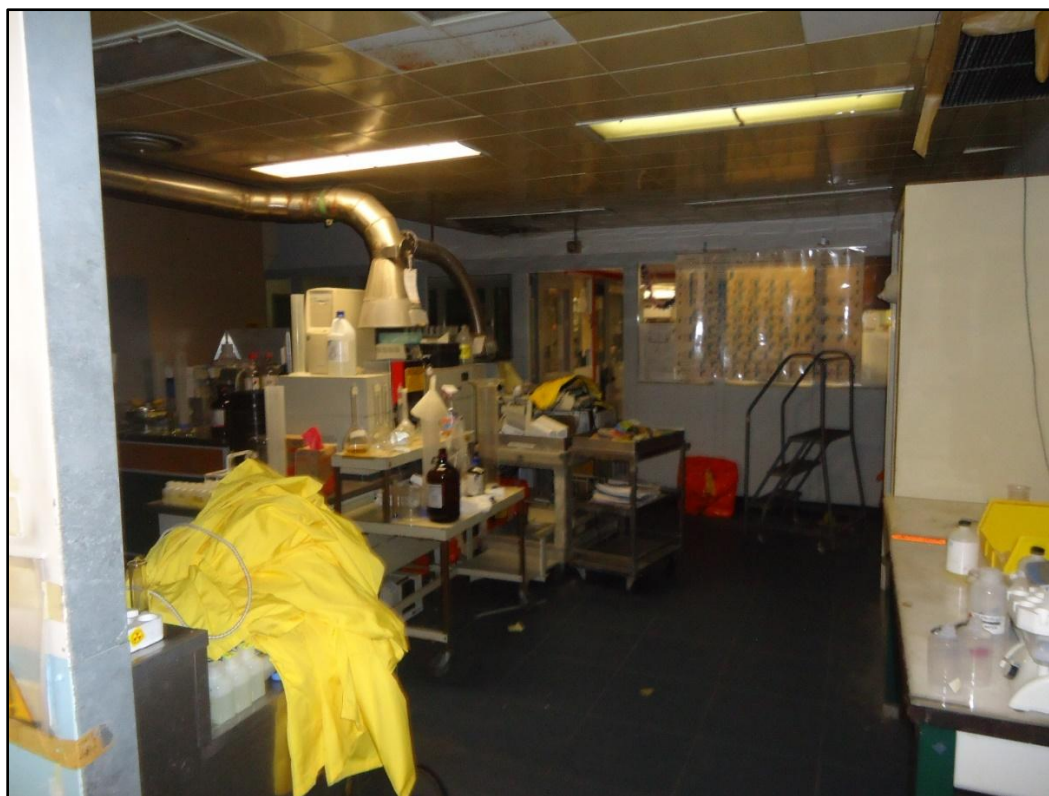
**Figure 6. Room 138, from Room 139, Looking South**

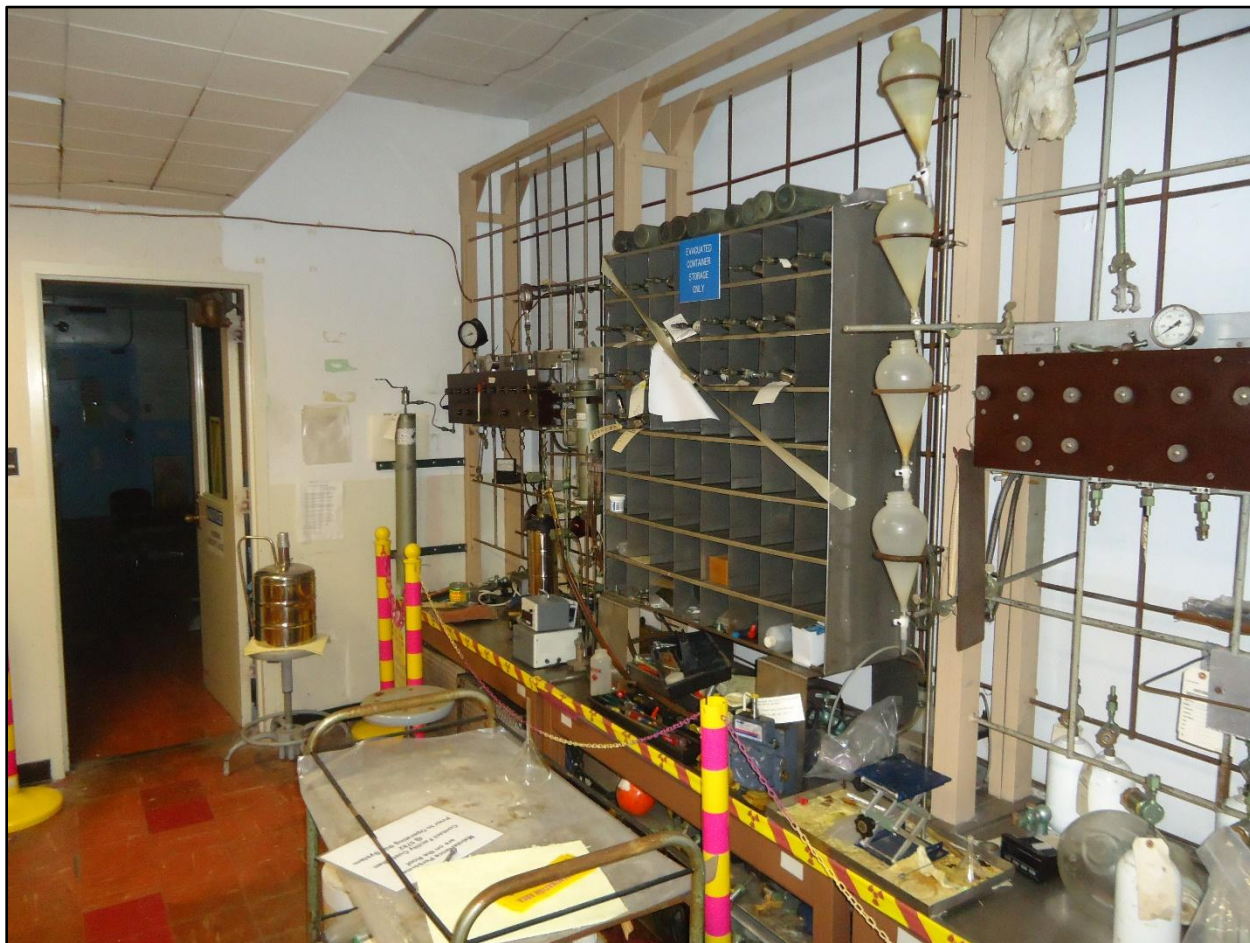
**Figure 7. Room 142, View Looking East**

Figure 7 shows the mail-slot storage system used for the sample cans.

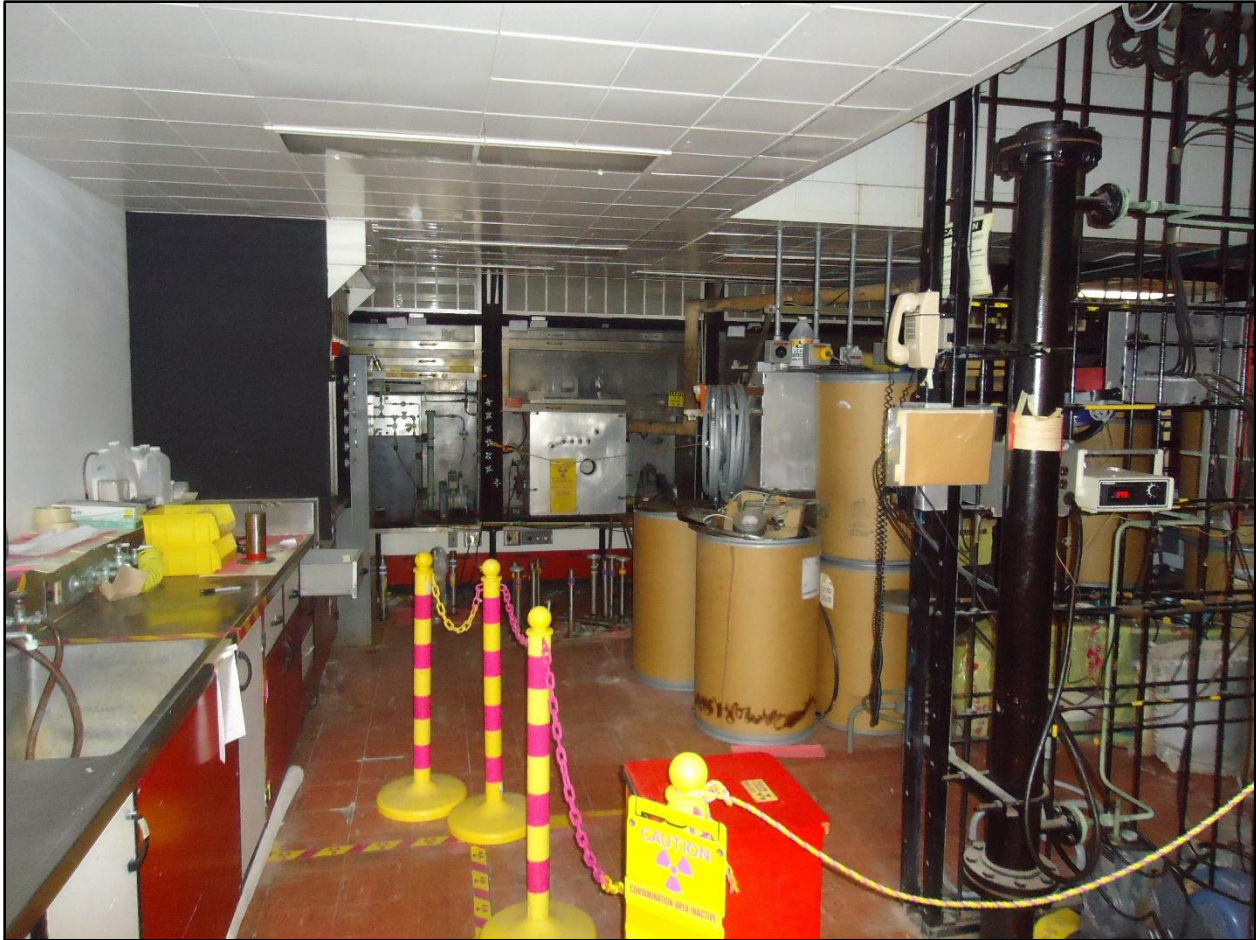
**Figure 8. Room 156, View from the South End Looking North**

In the 1956 floor plan layout, Room 156 was labeled as “UF<sub>6</sub> Reduction.” It was once used as a part of what was known as the Chemical Technology Group. This group conducted equipment testing, including pigtailed (connecting tubing) and valve experiments. This room has a fluorine delivery system in the bank of hoods on the north wall (as shown in Figure 8). Multiple Chemical Technology projects were also reported out of this room, including technetium-99 trap development and re-conditioning activities. The technetium-99 trap re-conditioning activities involved a process for these traps which were used in the reduction of technetium concentrations in the large cylinders by flowing feed gas from the parent cylinder to the daughter cylinder through technetium trap carts. This was a process performed in the X-340 Complex and was supported by this room in the X710. Reconditioning activities were conducted after

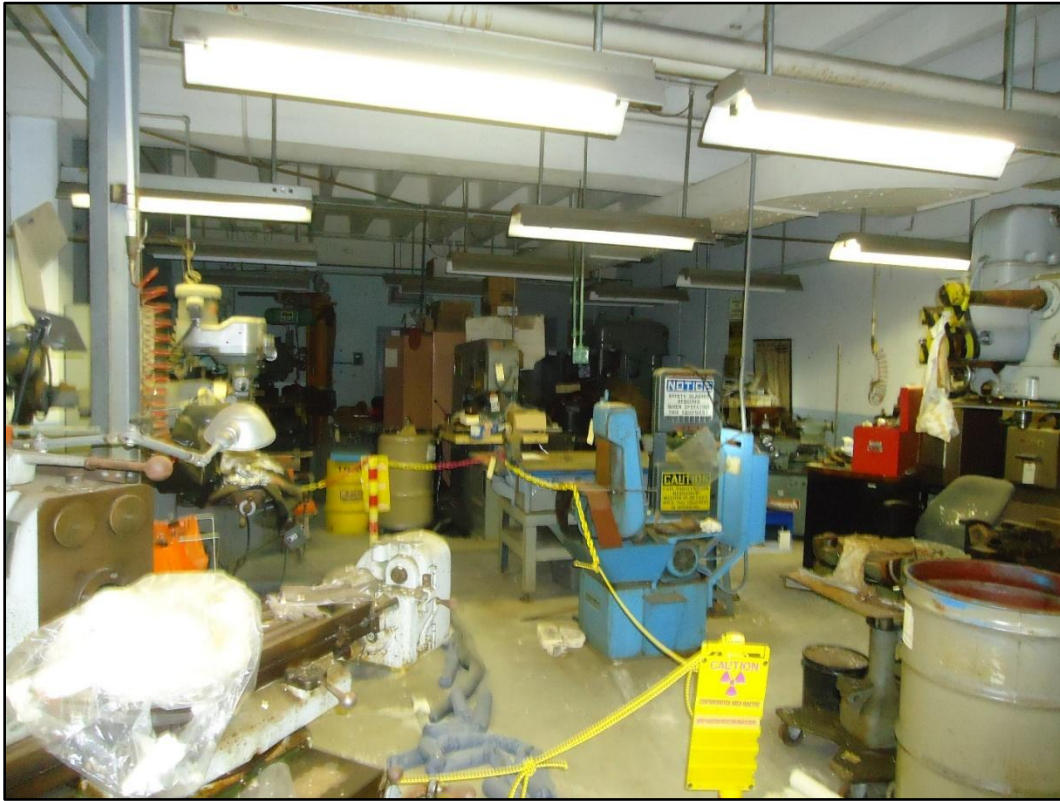
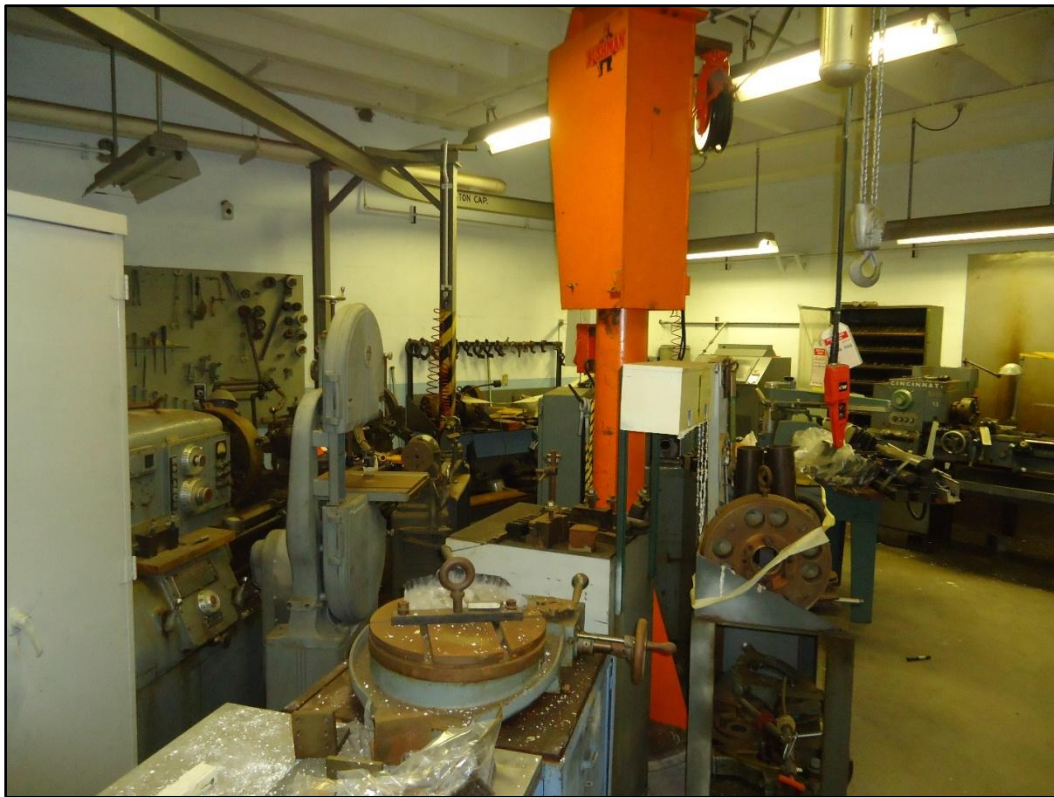
This room was identified on the original floor plan layout as “Machine Shop” and has continued that use throughout the history of the building. Equipment housed in this room includes lathes, drill presses, milling machines, metal band saws, and others. There was also a glass bead blasting chamber located in the northwest corner of the room. Figures 9 and 10 are photographs in the room from November 2023.

**Figure 9. Room 160, Machine Shop**

**Figure 10. Room 160 Machine Shop**

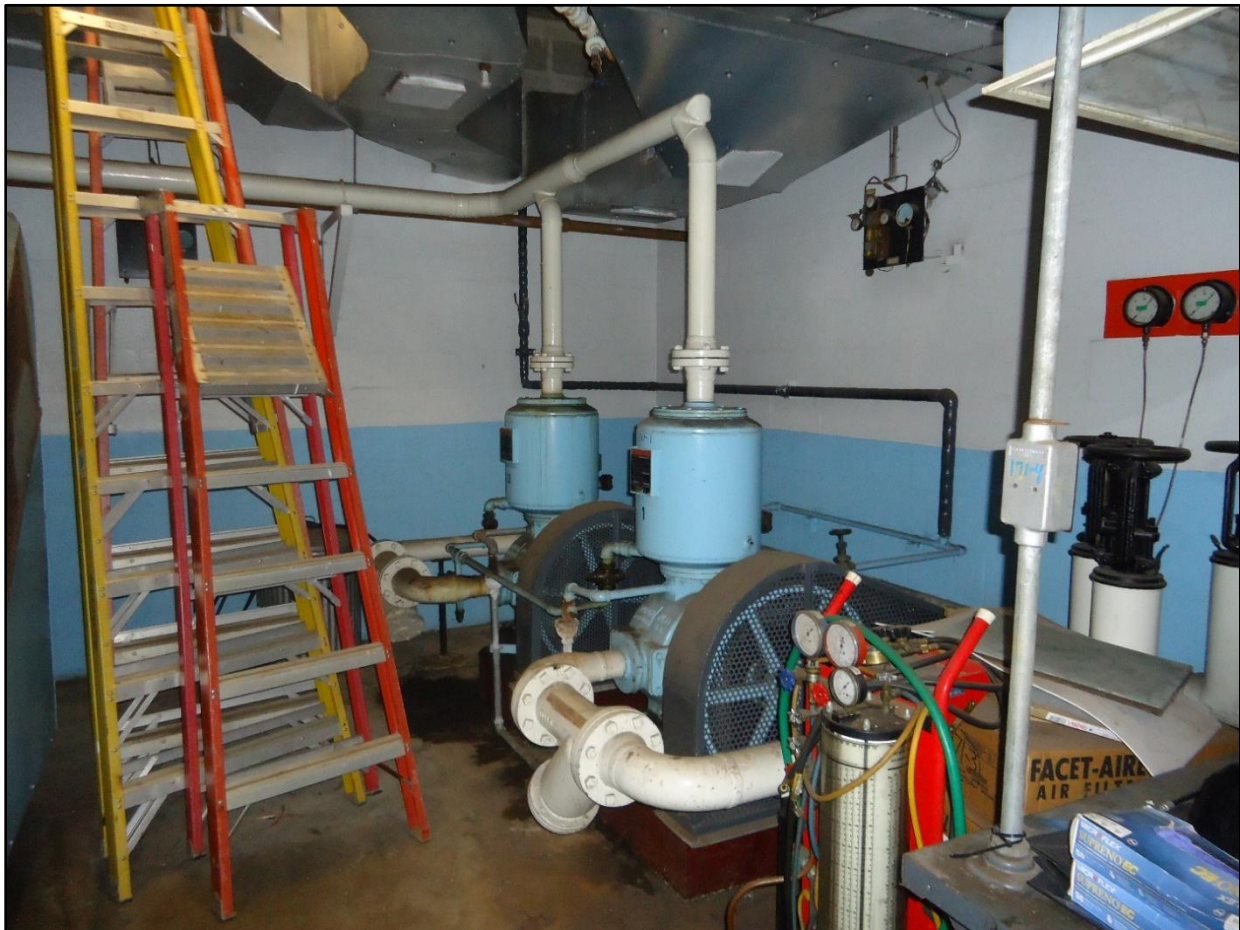
Figure 11. Room 171, Vacuum Pumps

Room 171 is a Mechanical Room, originally labeled in the 1956 floor plan layout as “Mechanical Equipment” and has been in continuous use for this purpose. Figure 11 shows the two vacuum pumps housed in this room.

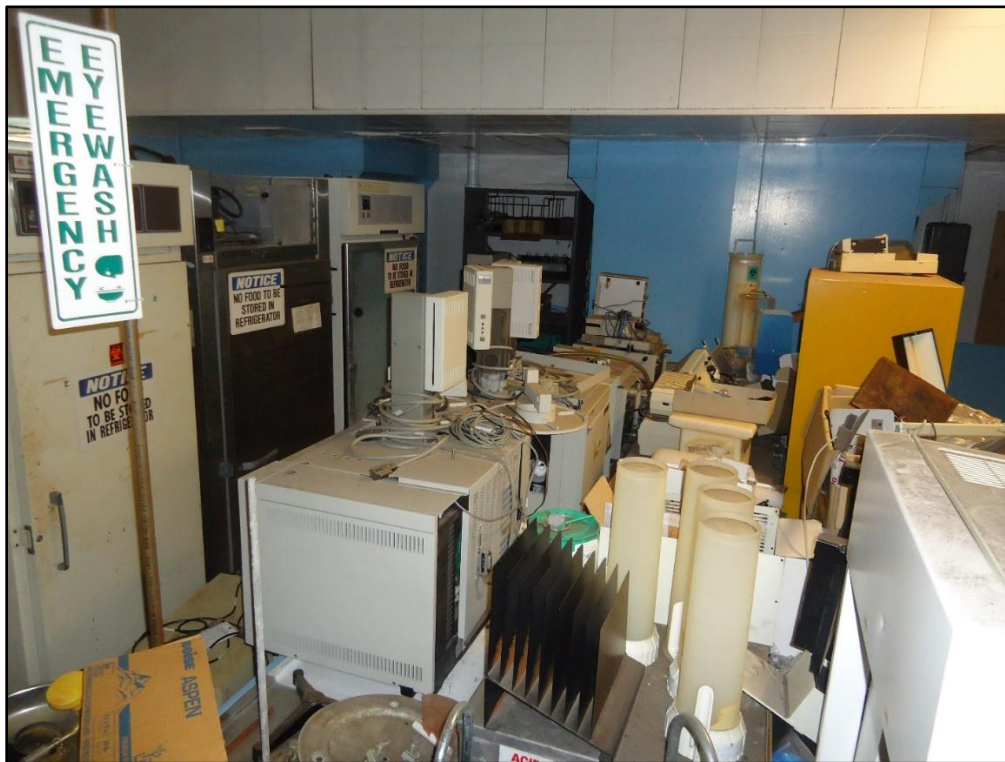
**Figure 12. View from Middle of Room 212, Looking West**

bearing solutions analysis. The area in Room 212 is awaiting deactivation and being currently used as a laboratory instrument graveyard. Figures 12 and 13 show the current storage activities in Room 212.

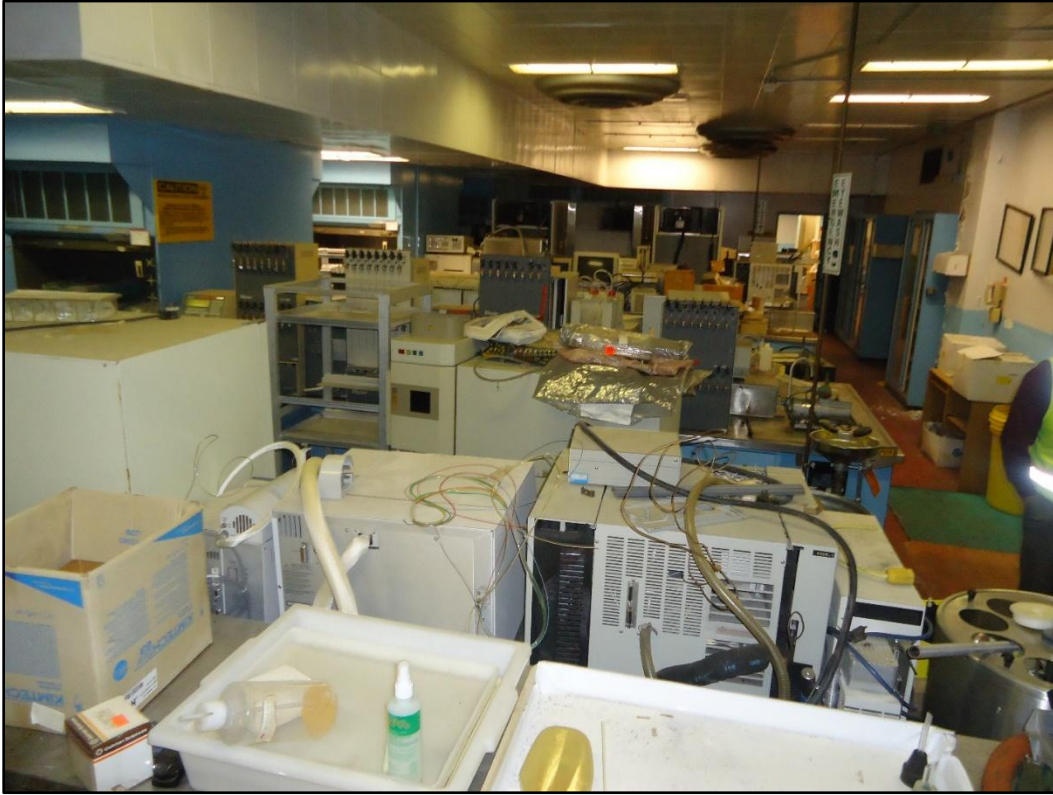
**Figure 13. Room 212 From South End Looking North**

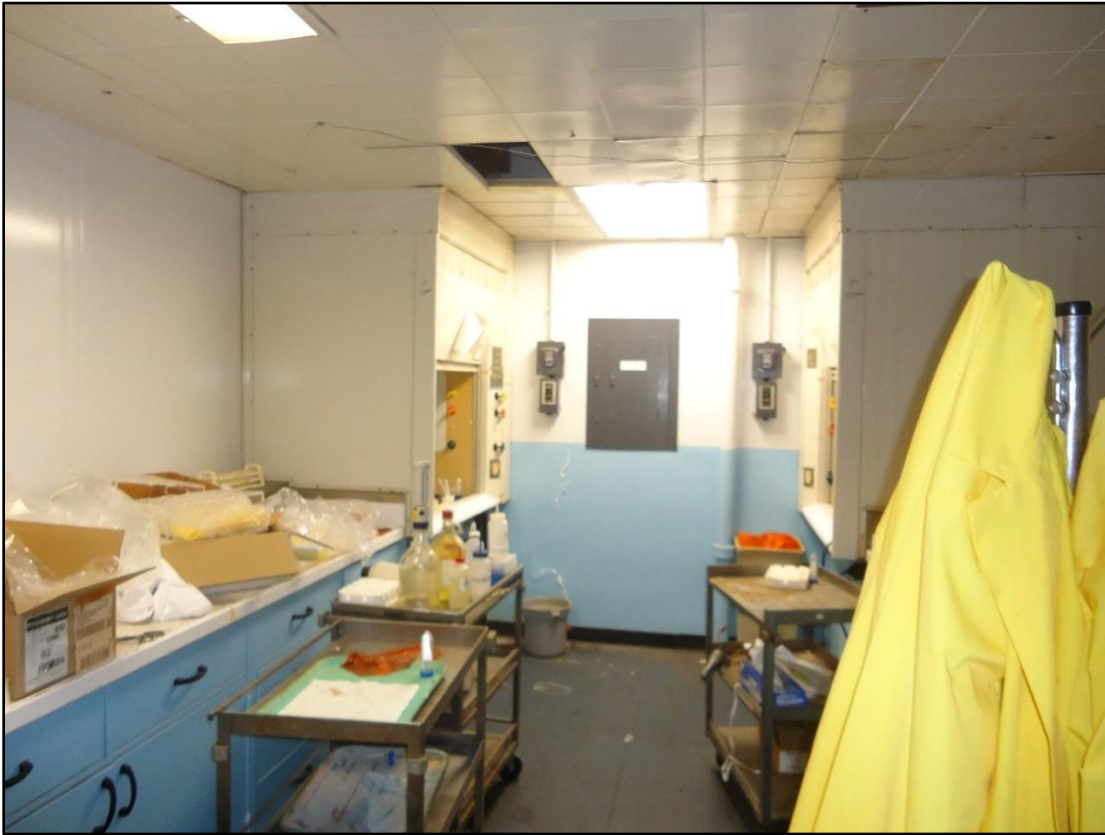
**Figure 14. Room 214, View from South Door Looking West (November 2023)**

Since the 2011 transition, Room 213 was the command center and Room 214 was the area where two atmospheric chambers were employed for bench scale testing for classified matter. Since 2014, the far north end (and ventilation hoods) was used to process laboratory samples from the X-326 Process Building Line Recorder instrument lines removed from the general area of Auxiliary Control Room 6. This material contained levels of technetium compounds which resulted in the fixed contamination of this area.

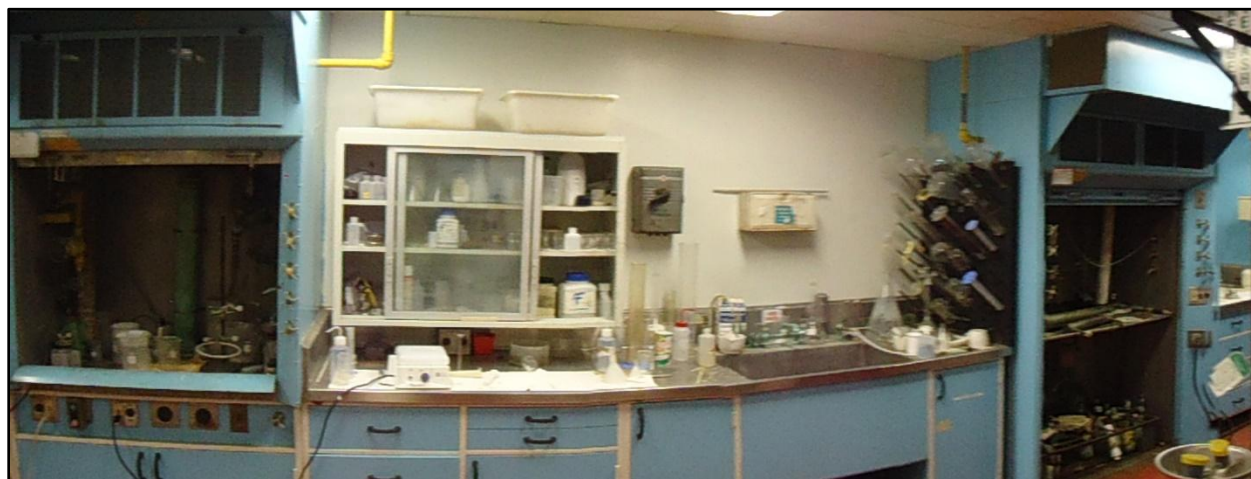
**Figure 15. Photograph of Room 240/241 - Left Portion of Panorama**

Figures 15 and 16 are left and right portions of a panoramic photograph view of Rooms 240/241.

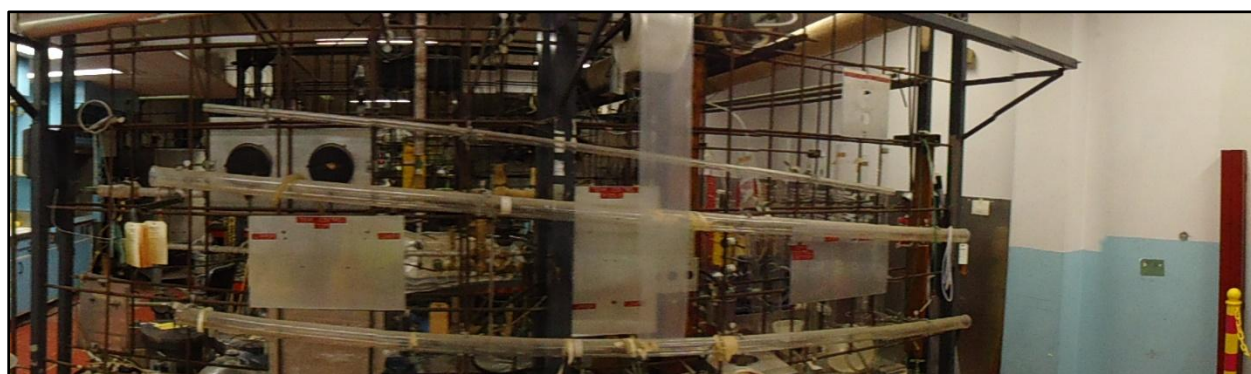
**Figure 16. Photograph of Room 240/241 - Right Portion of Panorama**

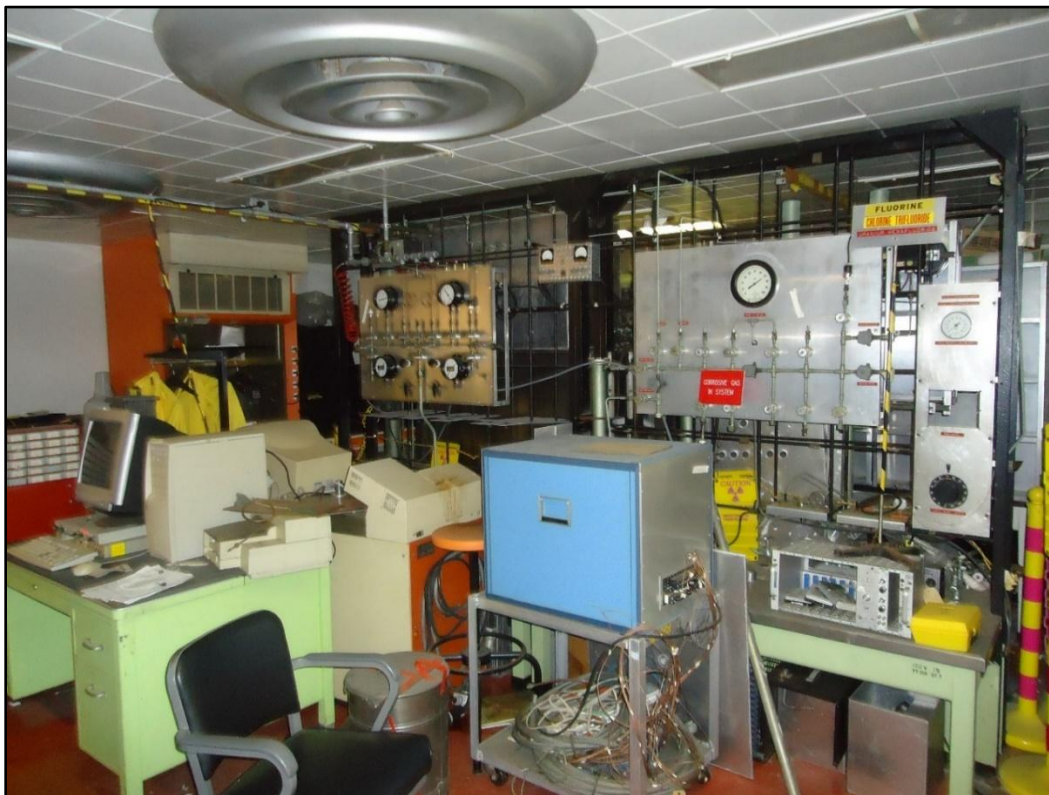
Figure 18. Room 243, From South Door Looking Northwest

The 1956 floor plan layout drawings labeled this room as “Interhalogen Process Studies”, but it is now known as the Radiochemistry Lab. Although this room has been included in coverage of one of the X-710 Technical Service Building nuclear criticality safety approval (NCSA) documents, it has never contained a fissile material operation. From Process Knowledge and evidence of the remaining ovens and manifold systems in the room, this was an area used for valve testing. Only non-enriched material would have been used in these tests as it would have been a waste of enriched material separative work units to use enriched uranium. There is access through the hood in this area to the building fluorine supply system as this was most likely necessary for appropriate valve evaluation.

Throughout the later 1980s, development of different online sampling systems was explored for sources under the EPA National Emission Standards for Hazardous Air Pollutants. This culminated in the final design of the Continuous Vent Stack Sampler that is still being used in three locations on site (plus one in use at the American Centrifuge Plant, next door to the PORTS) today. At one time, nearly 20 of these units were serviced from this area. These were all classified as non-fissile material operations as well. These Vent Stack Sampler support activities continued in this area until the cessation of all X-710 Technical Service Building laboratory activities in March 2021. Figures 18 & 19 depict Room 243.

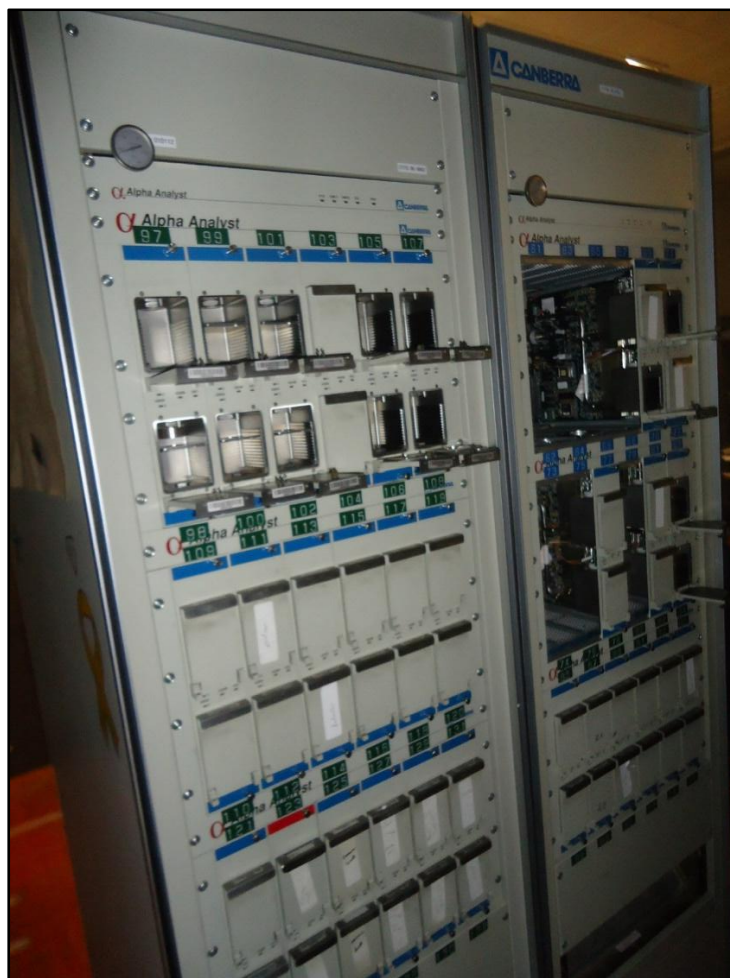
Figure 20. Photograph of Alpha Spec Rack and Chambers located in Room 244

These and other Radiochemistry rooms were addressed in NCSA 0710-015, and allowed to serve as an alternate sample receiving area (COC room) and, situationally due to other constraints, functioned as such. Early on, cleaning of glassware was performed in Chromic Acid baths later replaced by Sulfuric Acid baths with NOCHROMIX® additive. Figure 20 shows the Alpha Spec unit in Room 244.

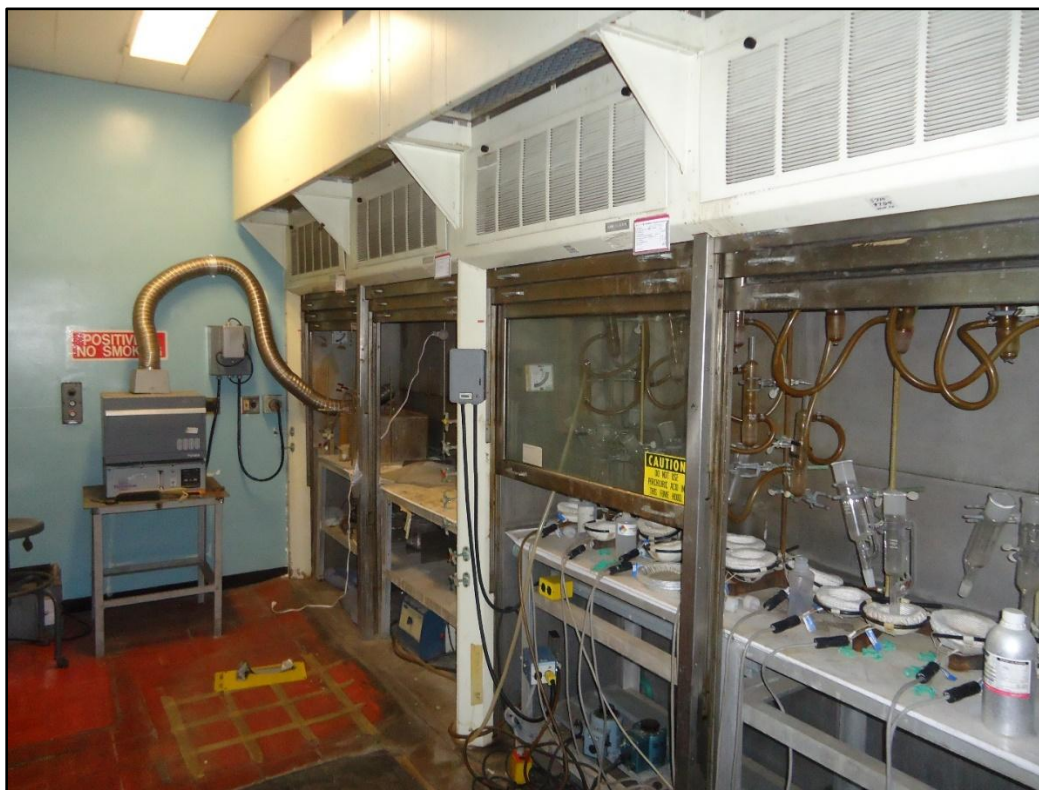
Figure 21. Room 263 Hoods

Throughout the 1980s and going forward, these rooms became a hub of preparatory work, where preparation of large volumes of samples for PCB analyses took place. To a somewhat lesser degree, both pesticides, herbicides, and some other specific organic compounds were also worked with in this area. In later years, probably after 2000, a couple of GC units with electron capture detectors (which contained nickel-63 radioactive sealed sources) were moved into what had been an administrative area consisting of Rooms 264 and 265. Known organic solvents used in high volume included hexane, acetone, methylene chloride, methanol, and a few others. Standards and mixtures of all Aroclor and Aroclor mixes (i.e., PCBs), pesticides, and herbicides, as well as other organic compounds were present. Early on, cleaning of glassware was performed in chromic acid baths and later replaced by sulfuric acid baths with NoChromix® additive. Figures 21 and 22 are photographs of Room 263 taken in November 2023.

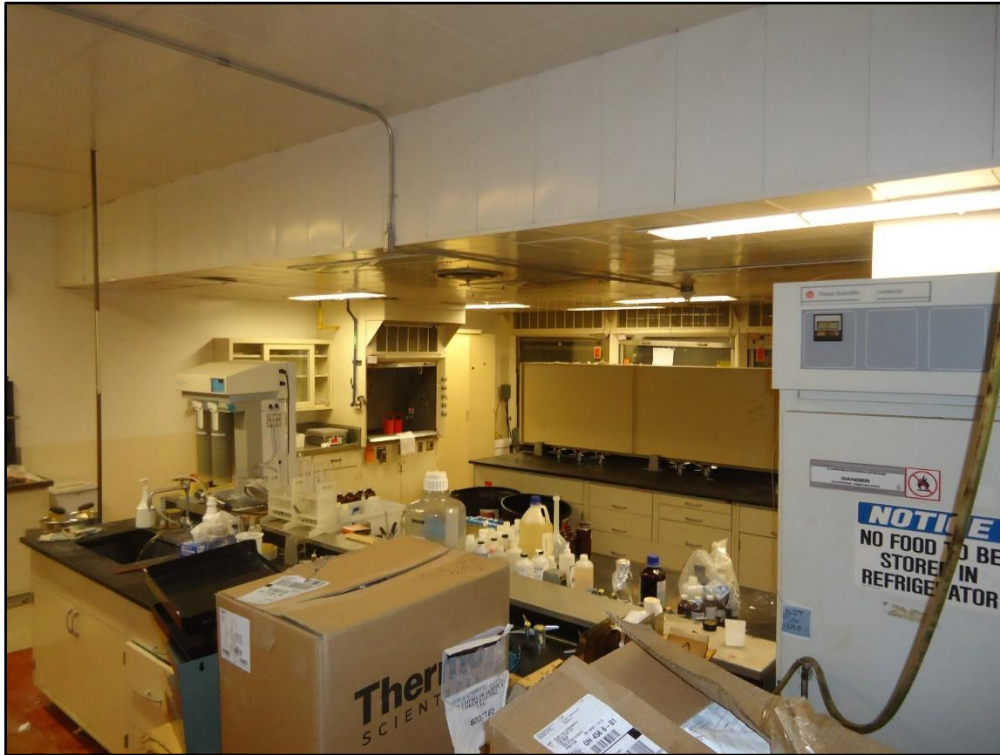
**Figure 23. Room 254 from North Door, Looking Southeast**

This room contains a bank of four hoods along the south wall. During startup of these operations in the early 1990's, these hoods were determined to contain levels of contamination. The far west hood was determined to have high levels of contamination behind the plenum that comes down the back of the hood directing airflow from front to rear across the floor. This became apparent when SVOC concentrating equipment became contaminated beyond salvage after a rain event resulted in washing contamination out of the hood. This hood was determined by Health Physics personnel (Radiation Protection program) to contain some of the highest levels of contamination in the X-710 Technical Service Building. Figure 23 is a photograph of Room 254 taken in November 2023.

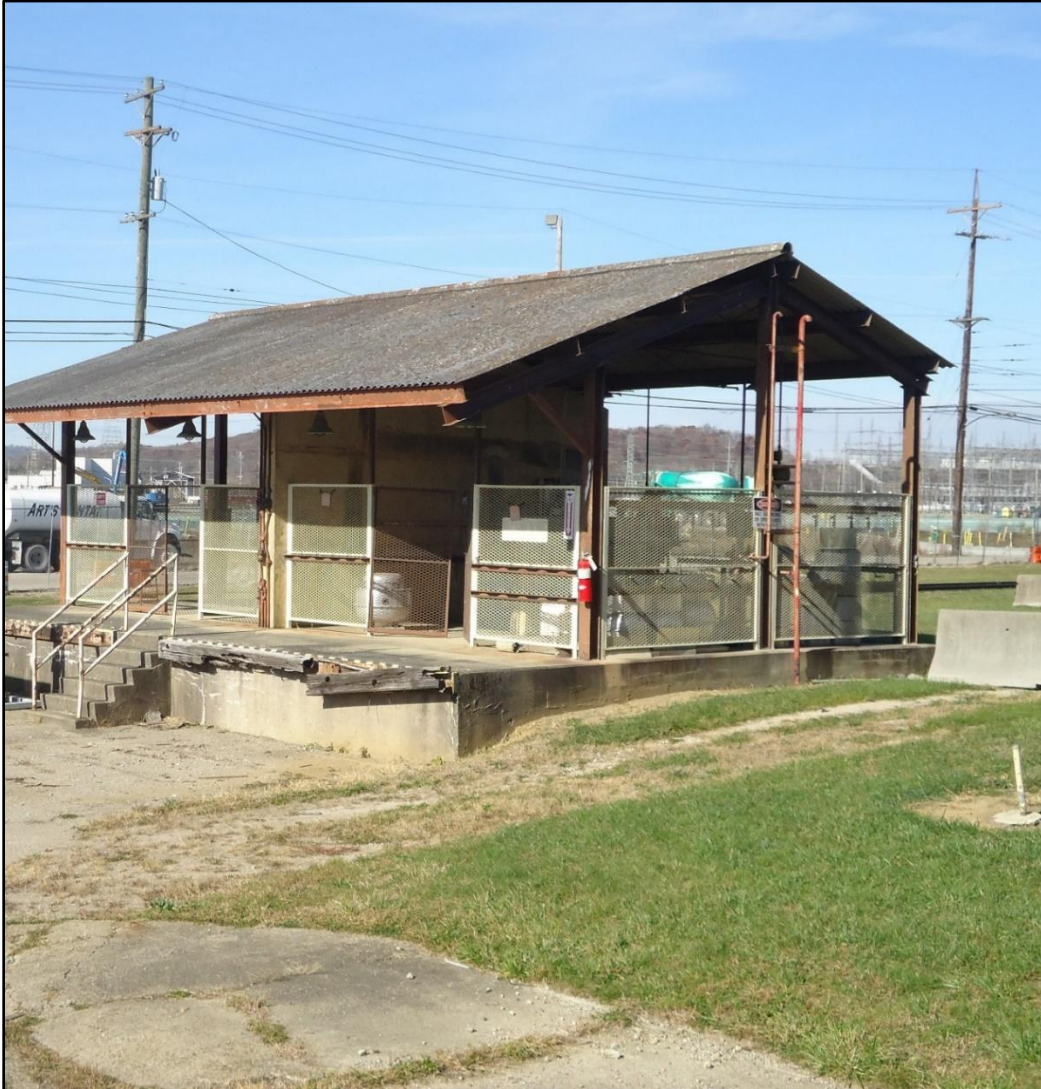
**Figure 24. X-710A Technical Service Gas Manifold Shed**

The X-710A Technical Service Gas Manifold Shed is an open-air structure built in 1955 located west of the X-710 Technical Service Building (see Figure 1 and also Figure 24). The facility was used for receiving, storing, and distributing specialized high-pressure gas through gas manifolds and cylinders for use in the laboratory areas of the adjacent X-710 Technical Service Building. The building constitutes an elevated concrete floor platform approximately 4 ft above grade, 37 ft long and 26 ft wide. The platform is enclosed with an expanded-metal fence and a shed-type corrugated cement asbestos (transite) panel roof supported by steel framing. A six-ft-wide loading dock adjoins one side of the structure and extends the full length of the shed. There are no walls, only a high chain-link fence which secured and enclosed the gas manifolds and cylinder storage area. The chain-link fence divides the platform into two storage areas. The gas cylinders have been removed. However, the previous configuration permitted oxygen cylinders to be contained in one storage area while the other contained hydrogen, liquid propane, and acetylene cylinders. Electricity is supplied to the X-710A Technical Service Gas Manifold Shed.

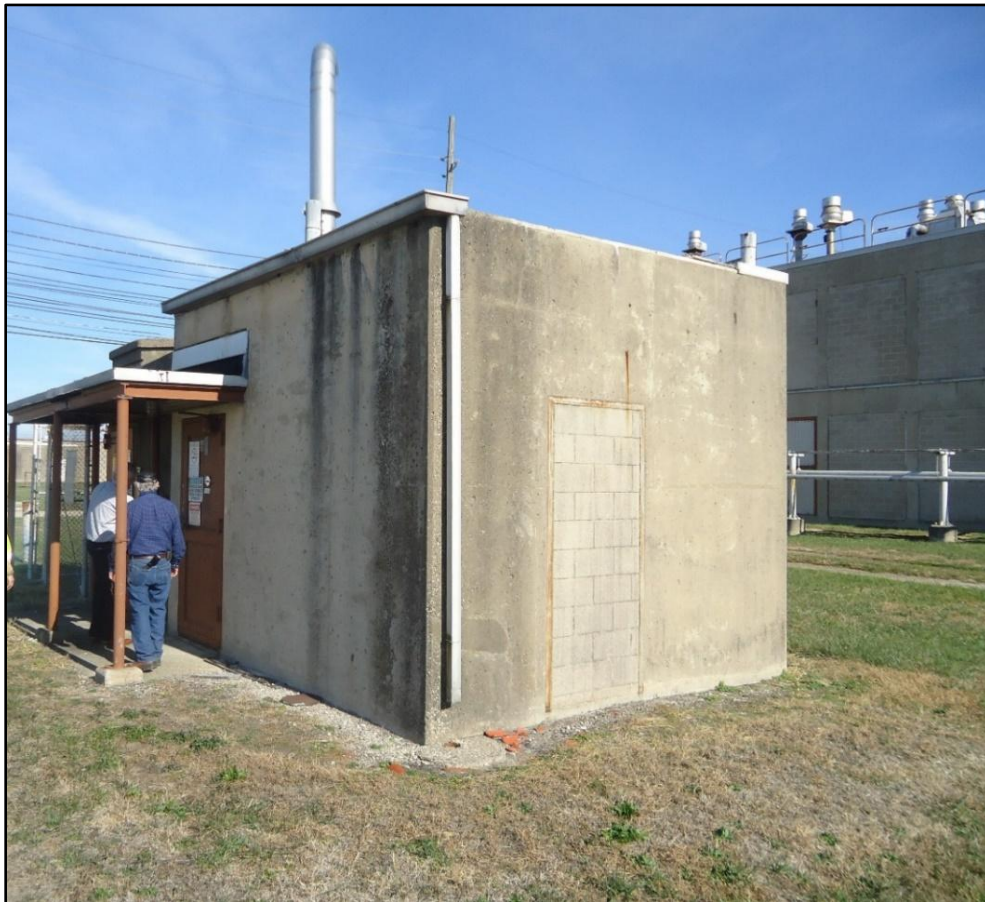
Figure 25. X-710B Explosion Test Facility

Blast-proof steel doors provide exterior access to the test chamber and work area. For manipulating test specimens, an 18-in. by 18-in. bullet-proof glass vision panel and sleeves for remote control were provided. Other operational equipment included a fume hood with a powered exhaustor and an acid-type sink that drained to the acid neutralization pit.

The facility was built to conduct experiments with unstable compounds that might result in an explosion. Based on interview information reported in *Report for Environmental Audit Supporting Transition of the Gaseous Diffusion Plants to the United States Enrichment Corporation, Appendix A, Volume II: Portsmouth Facilities Report* (DOE 1993), the facility had not been used to conduct experiments during the eight years prior to publication of that 1993 report. The facility had been utilized to store small gas cylinders that contained unknown gases manufactured onsite by a chemist.
